**ASTM E 90 SOUND TRANSMISSION LOSS
TEST REPORT**

SERIES/MODEL: DH93WW

TYPE: Double Hung Window

Report No: B7338.01-113-11

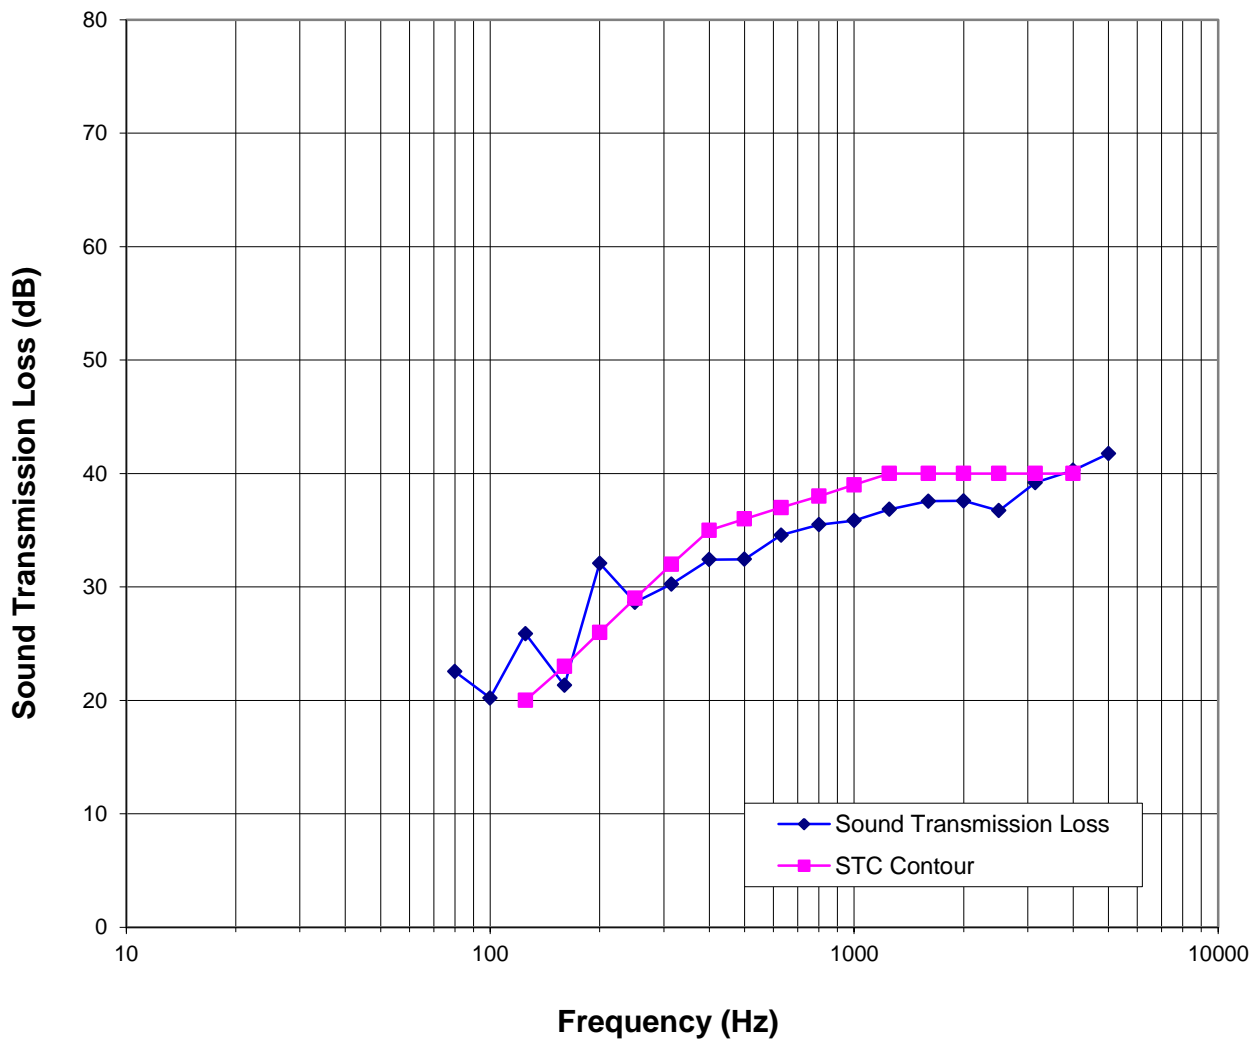
Sound Transmission Loss

ATI No. B7338.01A **Date** 04/02/12
Client Veka Inc.
Specimen Series/Model: DH93WW, double hung window with 31.8 mm (1-1/4") IG [6.4 mm (1/4") annealed, 19 mm (3/4") air space, 6.4 mm (1/4") laminated], Glass temperature 23.8°C (75°F)
Specimen Area 1.80 Square Meters
Filler Area 11.20 Square Meters
Operator Bradlay Hunt

STC Rating = 36 (Sound Transmission Class)
Deficiencies = 30 (Number of deficiencies versus contour curve)
OITC Rating = 31 (Outdoor/Indoor Transmission Class)

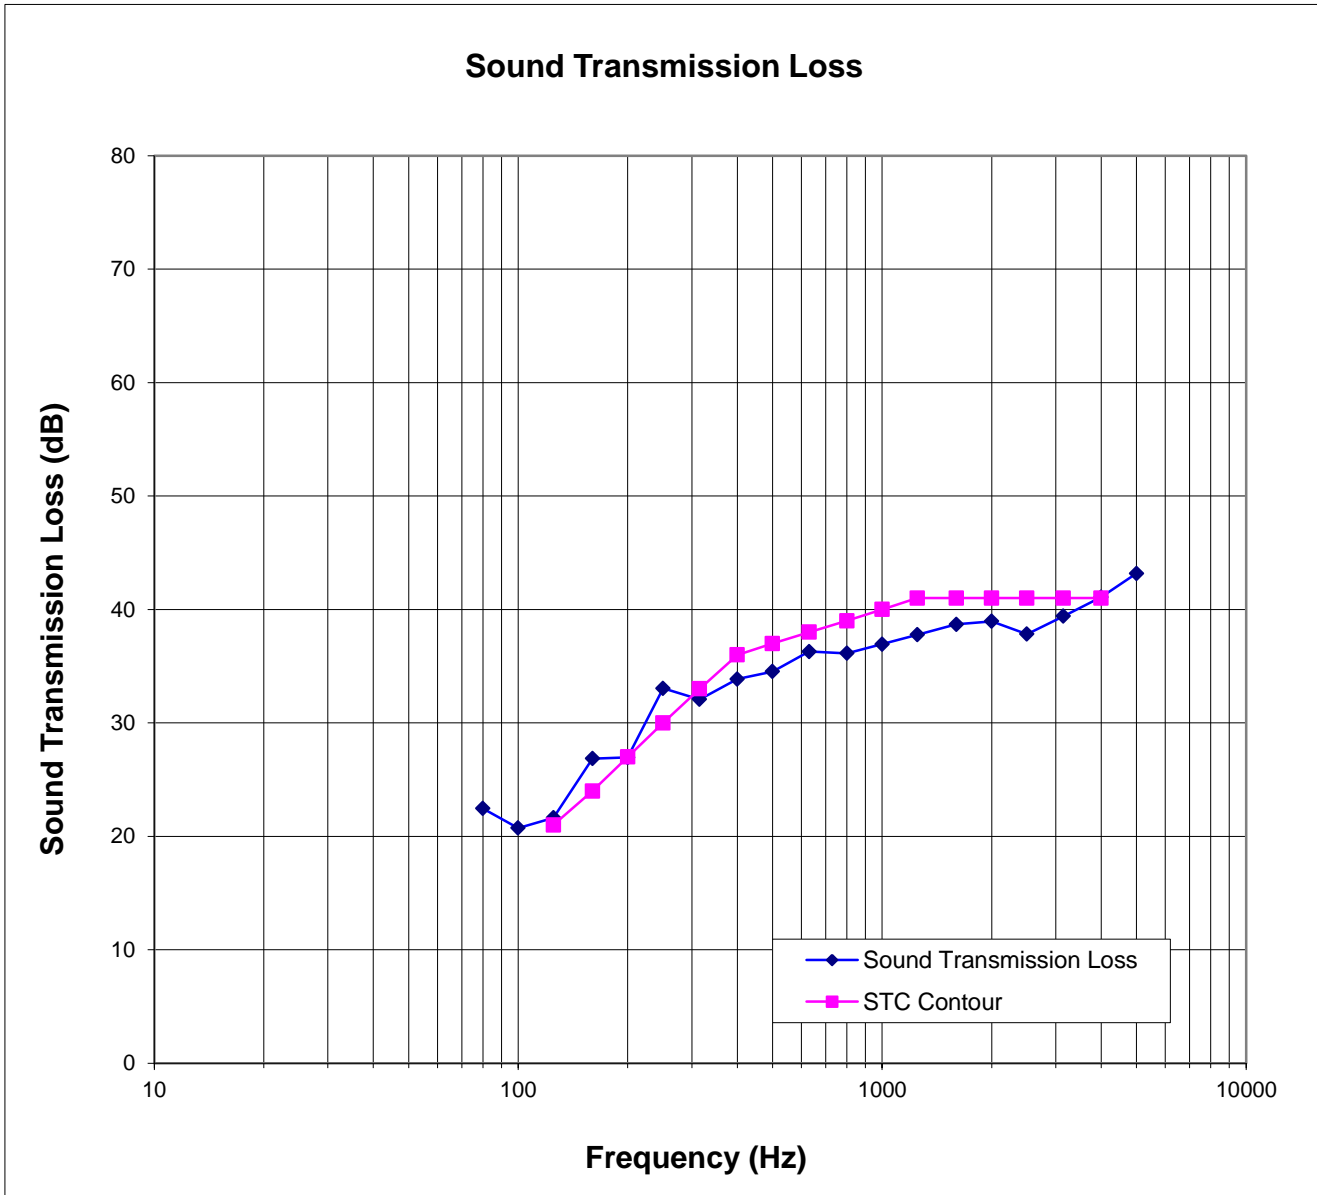
ATI No. B7338.01B **Date** 04/02/12
Client Veka Inc.
Specimen Series/Model: DH93WW, double hung window with 31.8 mm (1-1/4") IG [6.4 mm (1/4") laminated, 19 mm (3/4") air space, 6.4 mm (1/4") laminated], Glass temperature 23.8°C (75°F)
Specimen Area 1.80 Square Meters
Filler Area 11.20 Square Meters
Operator Bradlay Hunt

STC Rating = 37 *(Sound Transmission Class)*
Deficiencies = 25 *(Number of deficiencies versus contour curve)*
OITC Rating = 31 *(Outdoor/Indoor Transmission Class)*

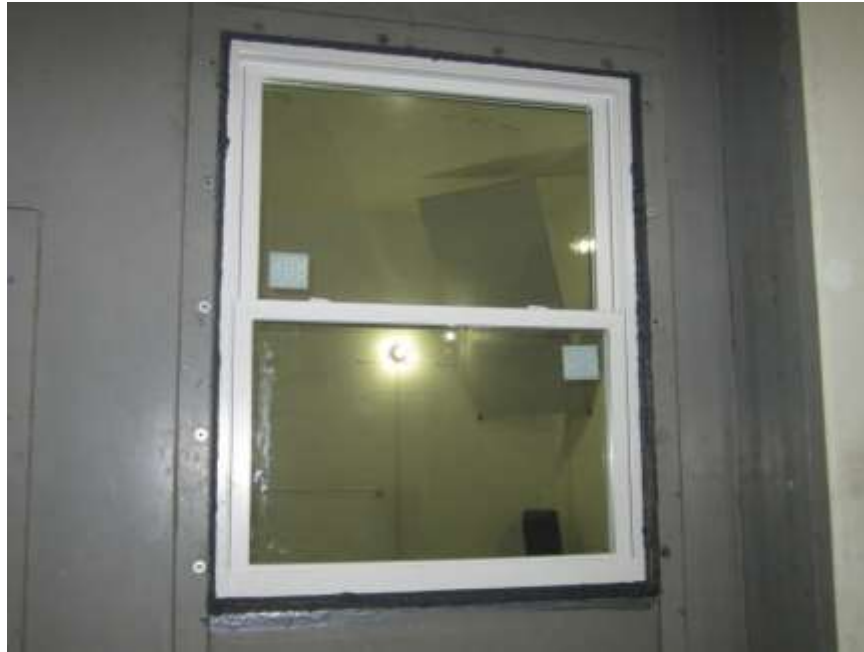
Receive Room View of Specimen Installation

A filler wall reducing element was used to reduce the test opening size. The reducing element consisted of two separate 51 mm (2") by 152 mm (6") wood frames filled with concrete to reduce the test opening size to accommodate the test specimen. A dense neoprene gasket was placed between the two wood and concrete frames. The window was placed on an isolation pad in the new test opening. Duct seal was used to seal the perimeter of the window to the test opening on both sides. The interior side of the window frame, when installed, was approximately 6.4 mm (1/4") from being flush with the receiving room side of the filler wall. A stethoscope was used to check for any abnormal air leaks around the test specimen prior to testing. The sash were opened and closed at least five times prior to testing.

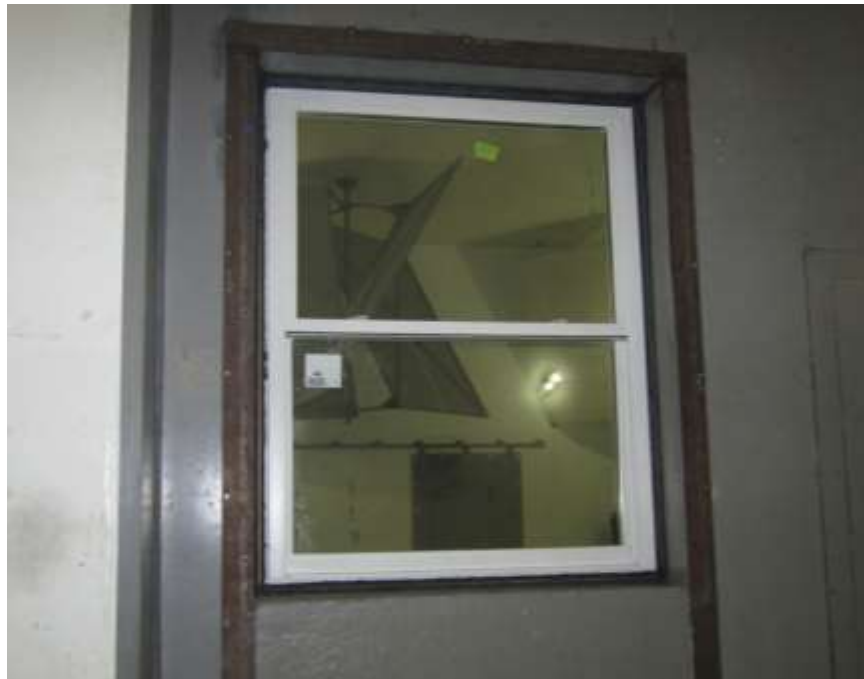
Source Room View of Specimen Installation
